Fuel Cell Power Plant Initiative

Final Report - Volume I Solid Oxide Fuel Cell/Logistics Fuel Processor 27 kWe Power System Demonstration for ARPA

November 1997

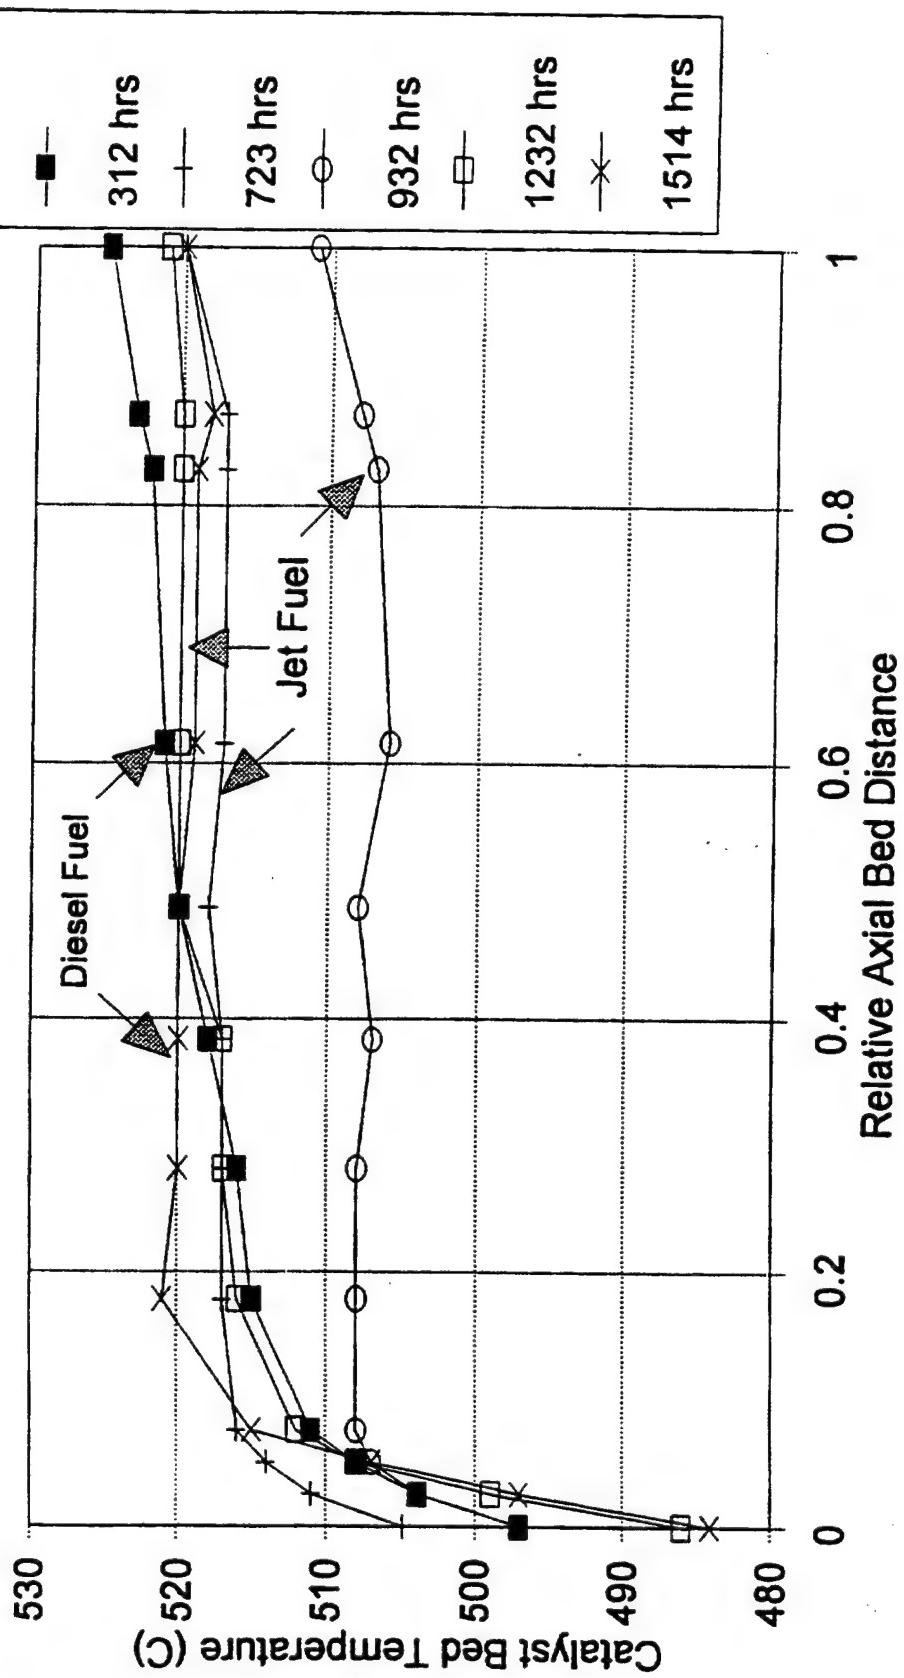
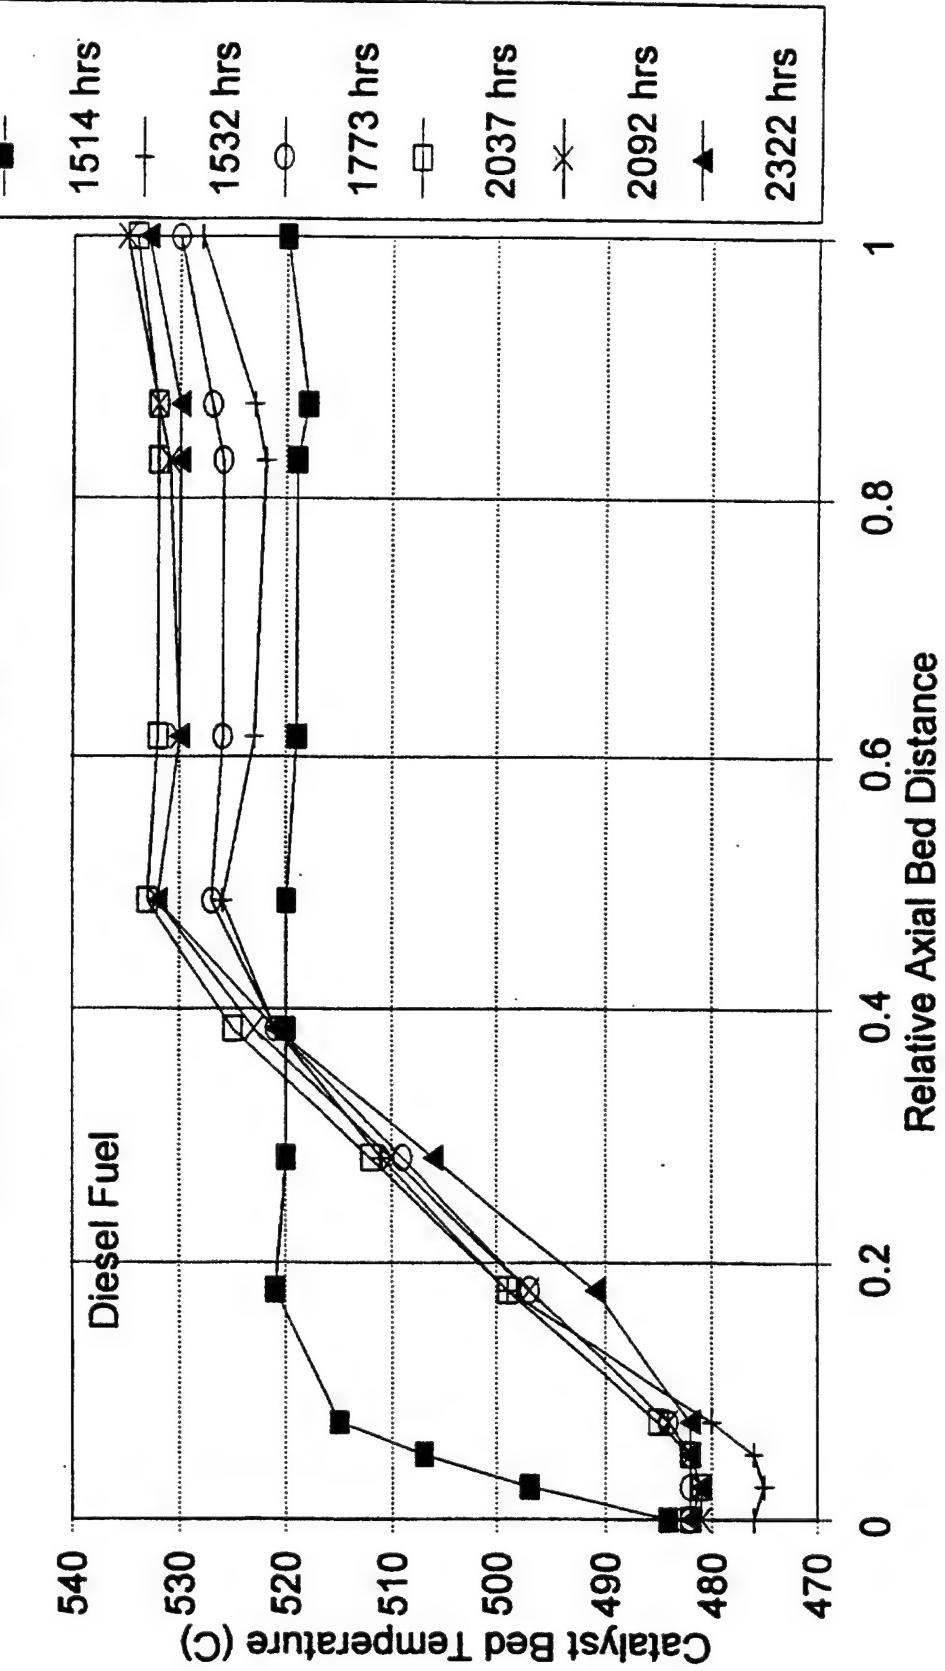
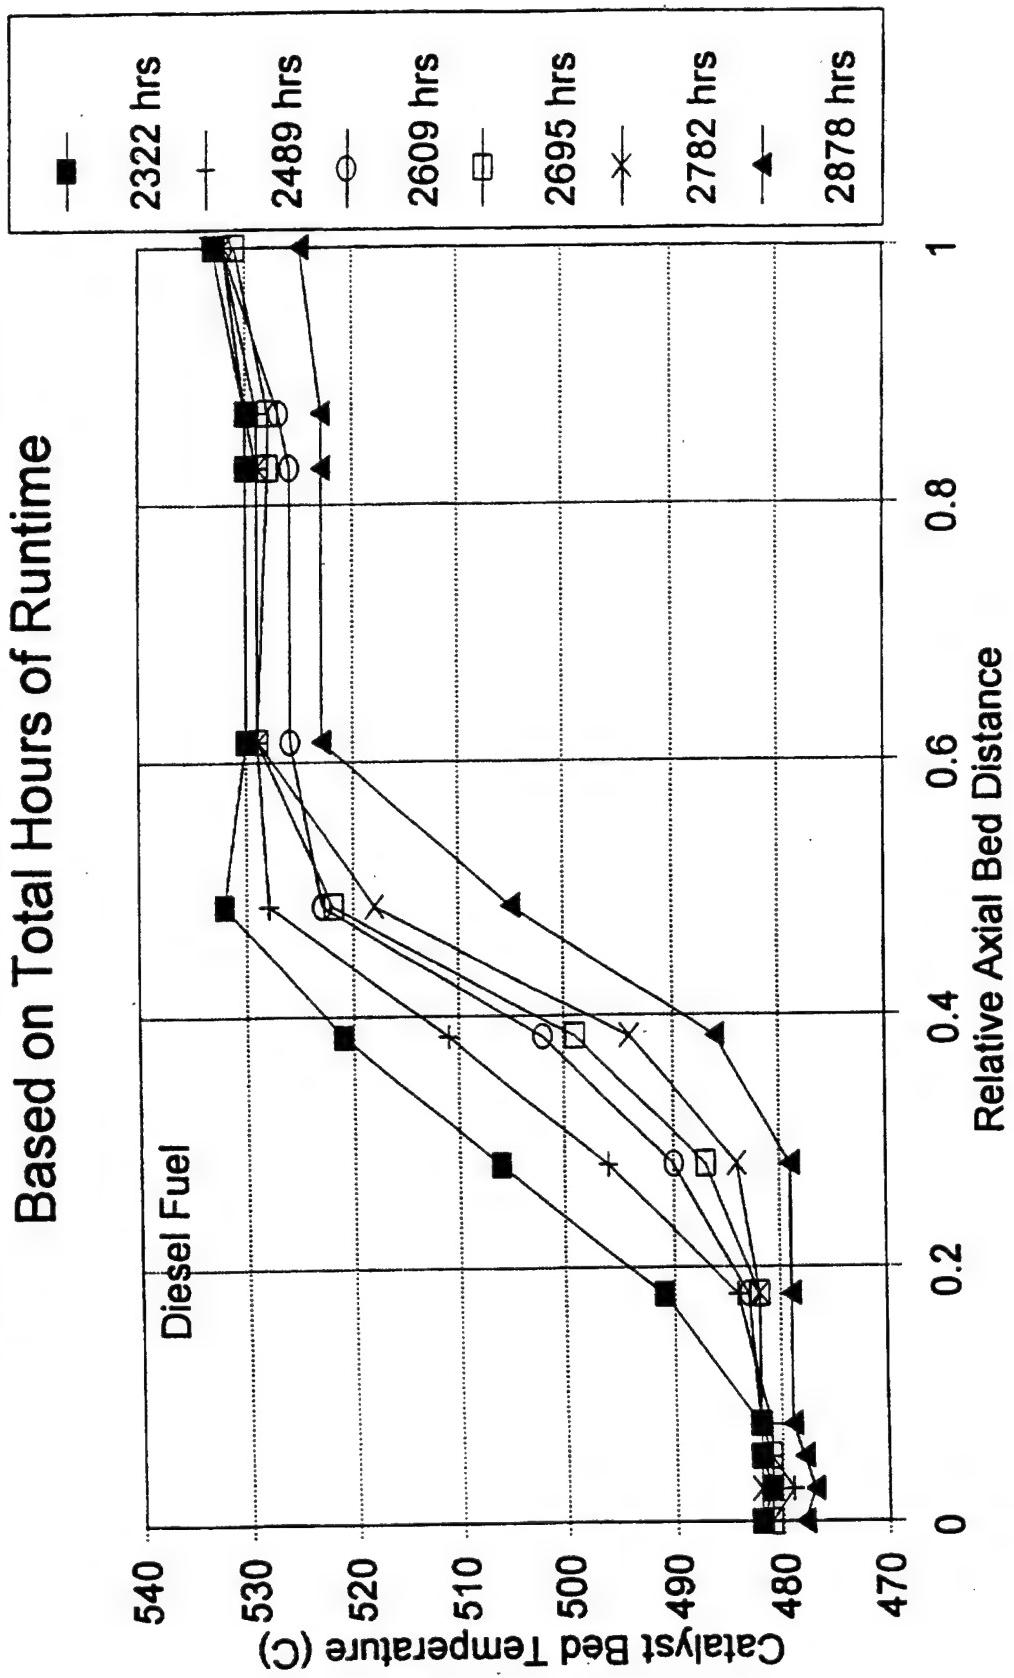
R-103 Temperature Profiles

During the last 550 hours of operation, some deactivation of the prereformer catalyst was seen. This is evidenced by the movement of the temperature profile. As seen no progressive movement of the profile is seen for the first 2300 hours of operation. The last 550 hours of prereformer run time correspond to the addition of thiophene to the diesel feed. No explanation is available as to why the HDS section did not completely remove the sulfur after thiophene was added.

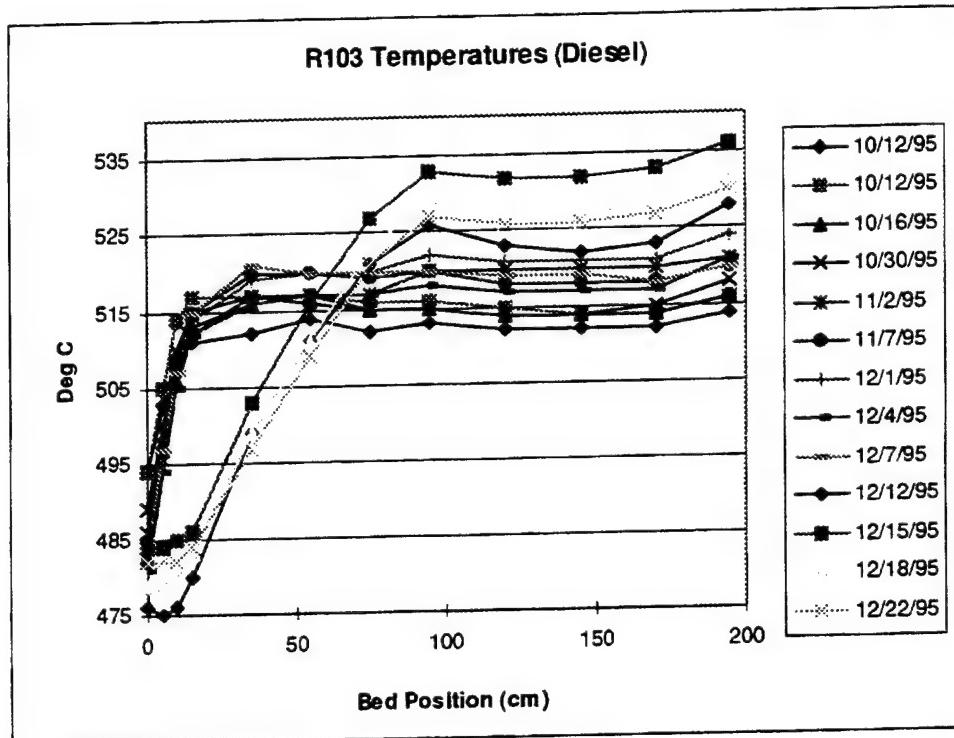
R-103 Temperatures

On 12/7/95 the LFP skid tripped due to a PLC halt. After the restart, the R-103 temperature profile had changed; the drop in upper bed temperatures indicating that the top portion of the catalyst bed had become deactivated. The following graph shows the change in the R-103 temperature profile following the restart.
